## Field Assessment Manual

Zumbro River Watershed  
Restoration Prioritization

## **Zumbro River Watershed Restoration Prioritization Project**

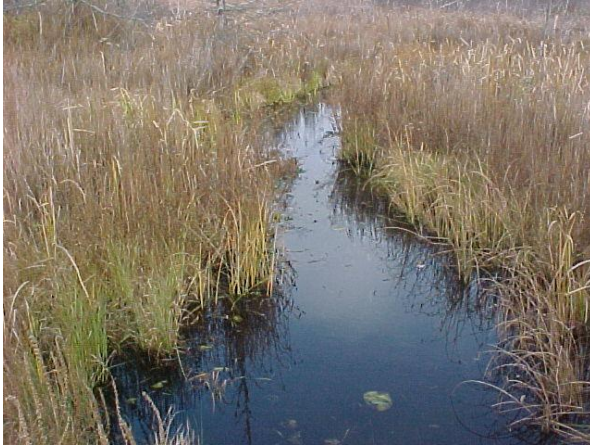
**Figure A. Tributary, Kalamazoo River watershed**

Figure A depicts a small stable stream setting.

Completing a streambank erosion inventory form at this site would not be necessary. This stream illustrates well-established perennial vegetative cover. The buffer width is > 30 feet.

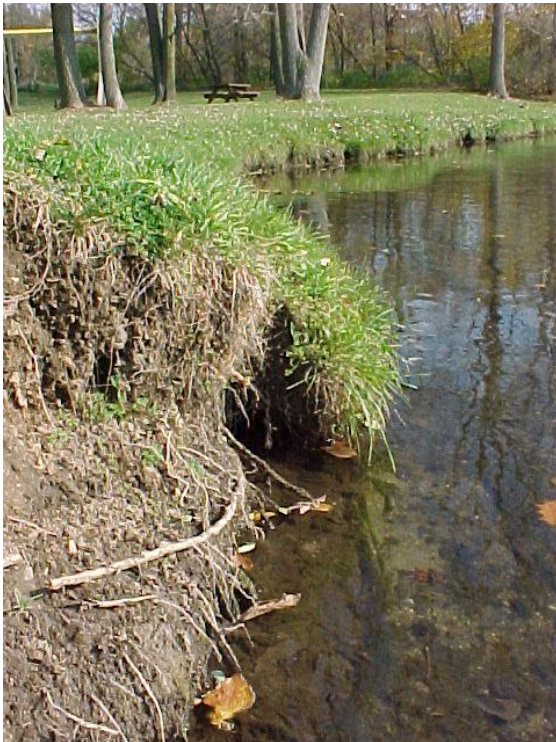
**Figure B. Kalamazoo River**

Figure B depicts a site with noticeable bank erosion.

Exposed roots indicate active erosion. Slumped soils indicate undercutting typical for erosion induced by channel hydrology. This stream has poor perennial vegetative cover (shallow grass roots and sparse woody vegetation density). The buffer width is < 10 feet.

For this site, the evaluation would measure the bank height using the average dimension along the bank that stretches from submerged toe of the slope to grassed soil horizon.

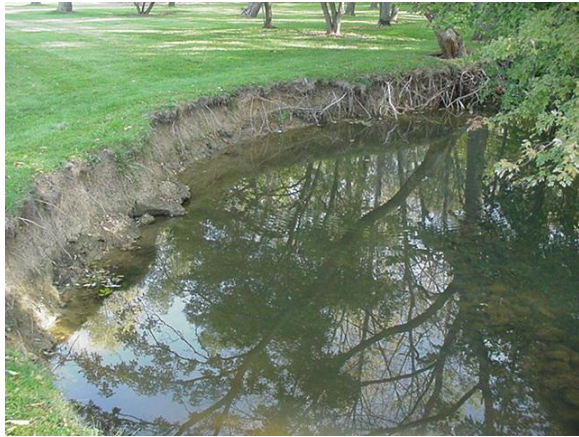
### Figure C. Rouge River

Figure C depicts a site with outside bend bank erosion.

For this site, a streambank erosion assessment would be conducted. The erosion illustrated here is typical of erosion induced by channel hydrology. Perennial vegetative cover is poor. The buffer width is < 10 feet.

This site is an interesting example of bank erosion. Grass/woody roots extend to the waterline, but are so few and shallow that they provide minimal bank protection. Also, this site is downstream from a dam (not pictured). Impoundments usually are associated with atypically high erosion due to increased sediment transport capacity as a result of the low sediment concentrations in the water released from the impoundment.

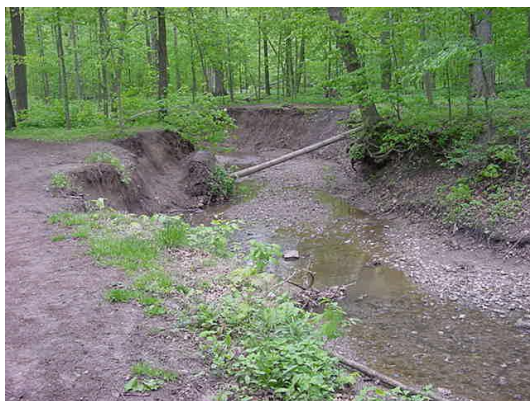
### Figure D. Hagar Creek, Ottawa County, MI

Figure D depicts a site with active erosion on at least three bank locations.

The tree root balls shown slumping into the stream (middle of the photo) is typical of erosion induced by channel hydrology. The near bank to the left has poor woody vegetative cover and poor grass understory cover. Buffer width is < 10 feet.

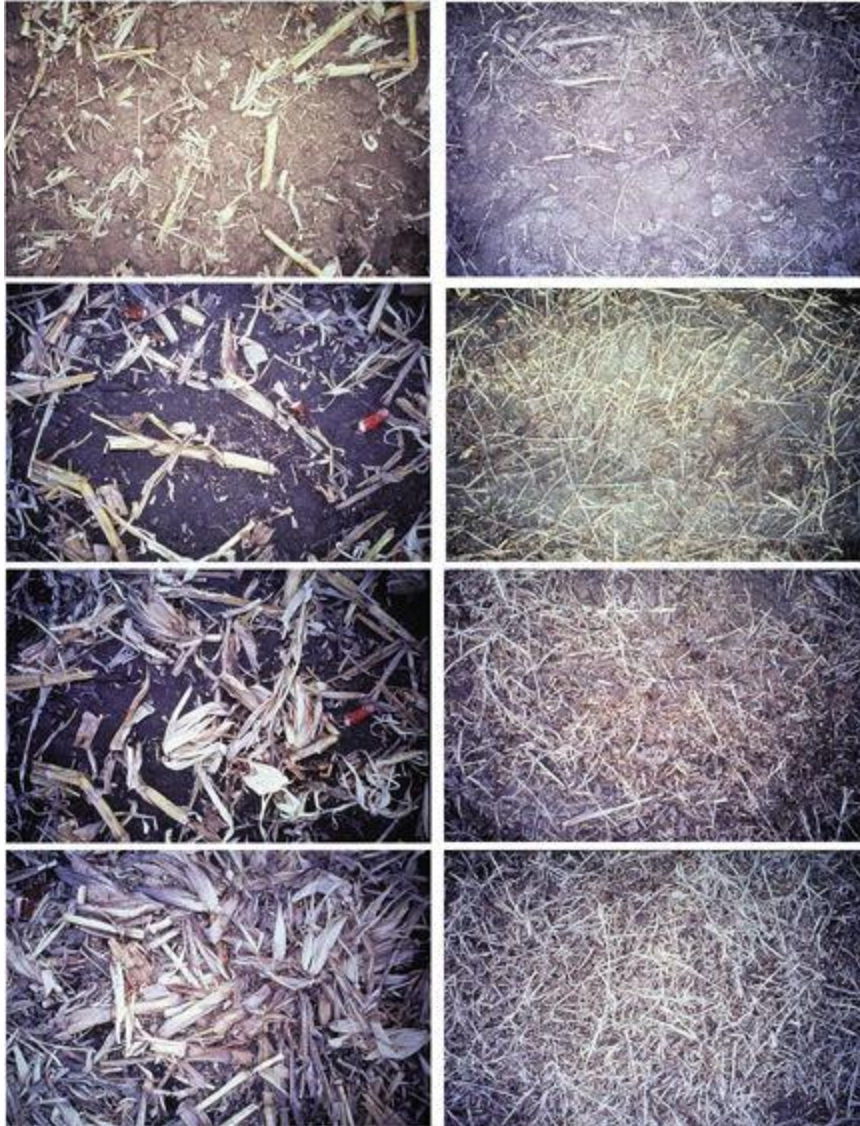
**Figure G. Visual crop residue examples**

The images in the vertical columns show crop residues for corn (left) and soybean (right) – From top to bottom: 25%, 50%, 75%, 90%

- Determine buffer information. If the feature is located in forested land, these can be ignored unless other buffer concerns exist.
2. **Determine upland field characteristics** – These include land use, tillage, and tile information. Also note any evidence or knowledge of recent or current manure application. For % crop residue, see appendix 2 for a visual example of various percentages.
