# Environment and Natural Resources Trust Fund (ENRTF) M.L. 2016 Work Plan

**PROJECT TITLE:** Agricultural Runoff Water Quality Treatment Analysis- Phase II

## Case Study: Blue Earth County Ditch 57

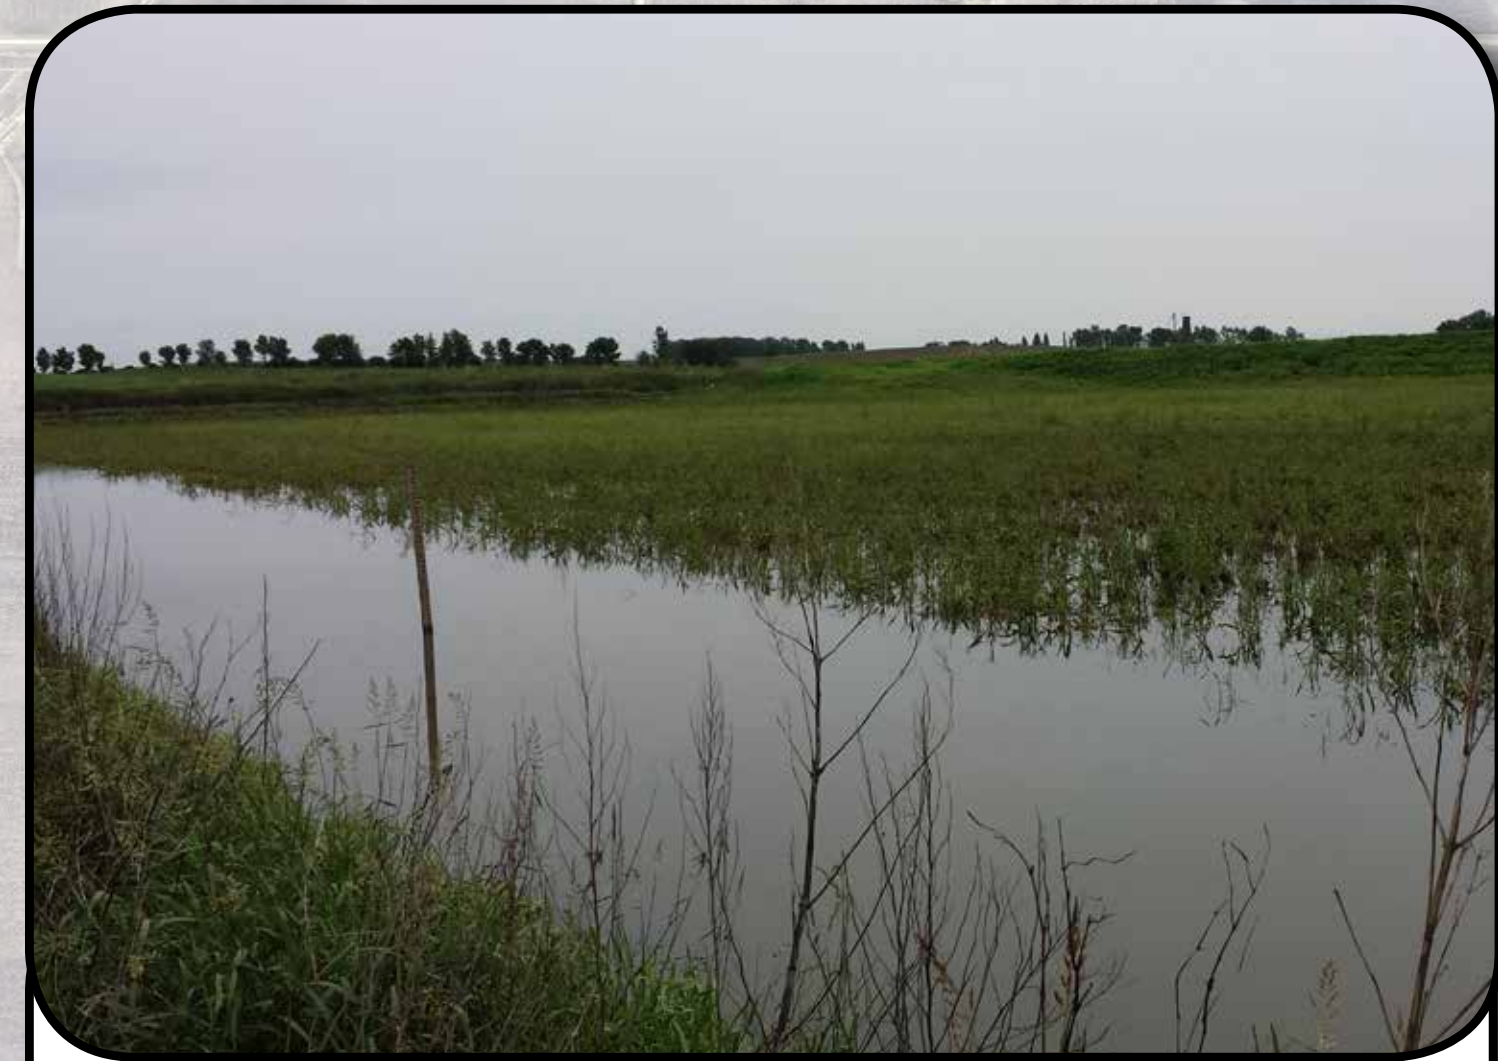
### Water Quality and Rate Control: Klein Pond/Surge Basin

The Klein Pond was excavated adjacent to the mainline ditch in an area that often flooded out. Runoff from the mainline is diverted into the pond under normal flow conditions, providing both rate control (reducing peak flows) and water quality improvements.

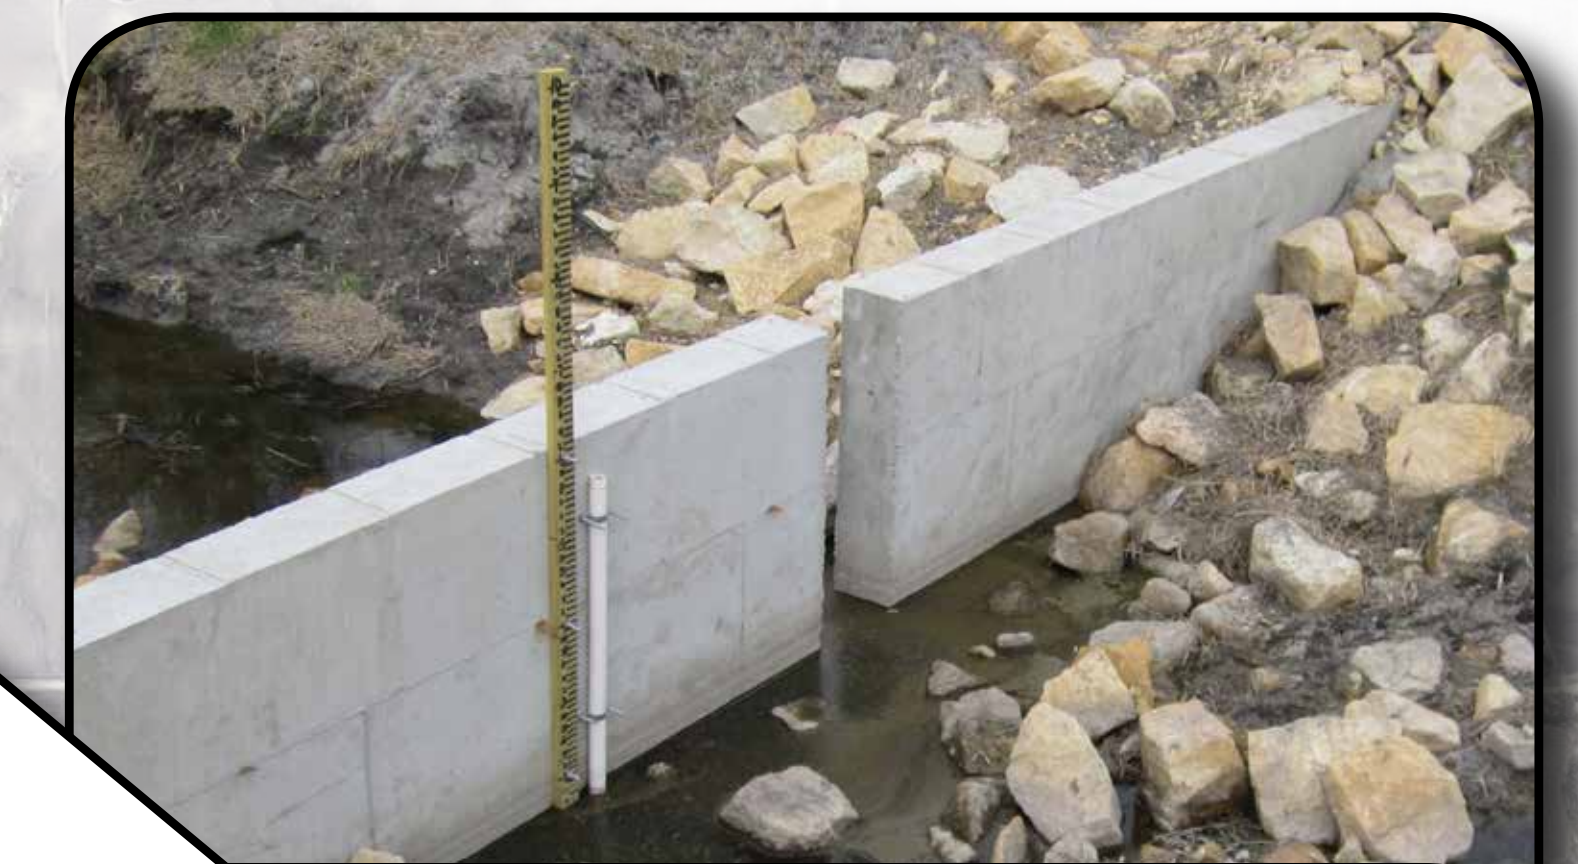
### Water Quality and Rate Control: Weir Structure

This weir, placed at the outlet of the system prior to discharge into the Big Cobb River. This structure reduces the peak discharge rate during smaller storm events by detaining water upstream of the weir. This detention has the added benefit of improving water quality.

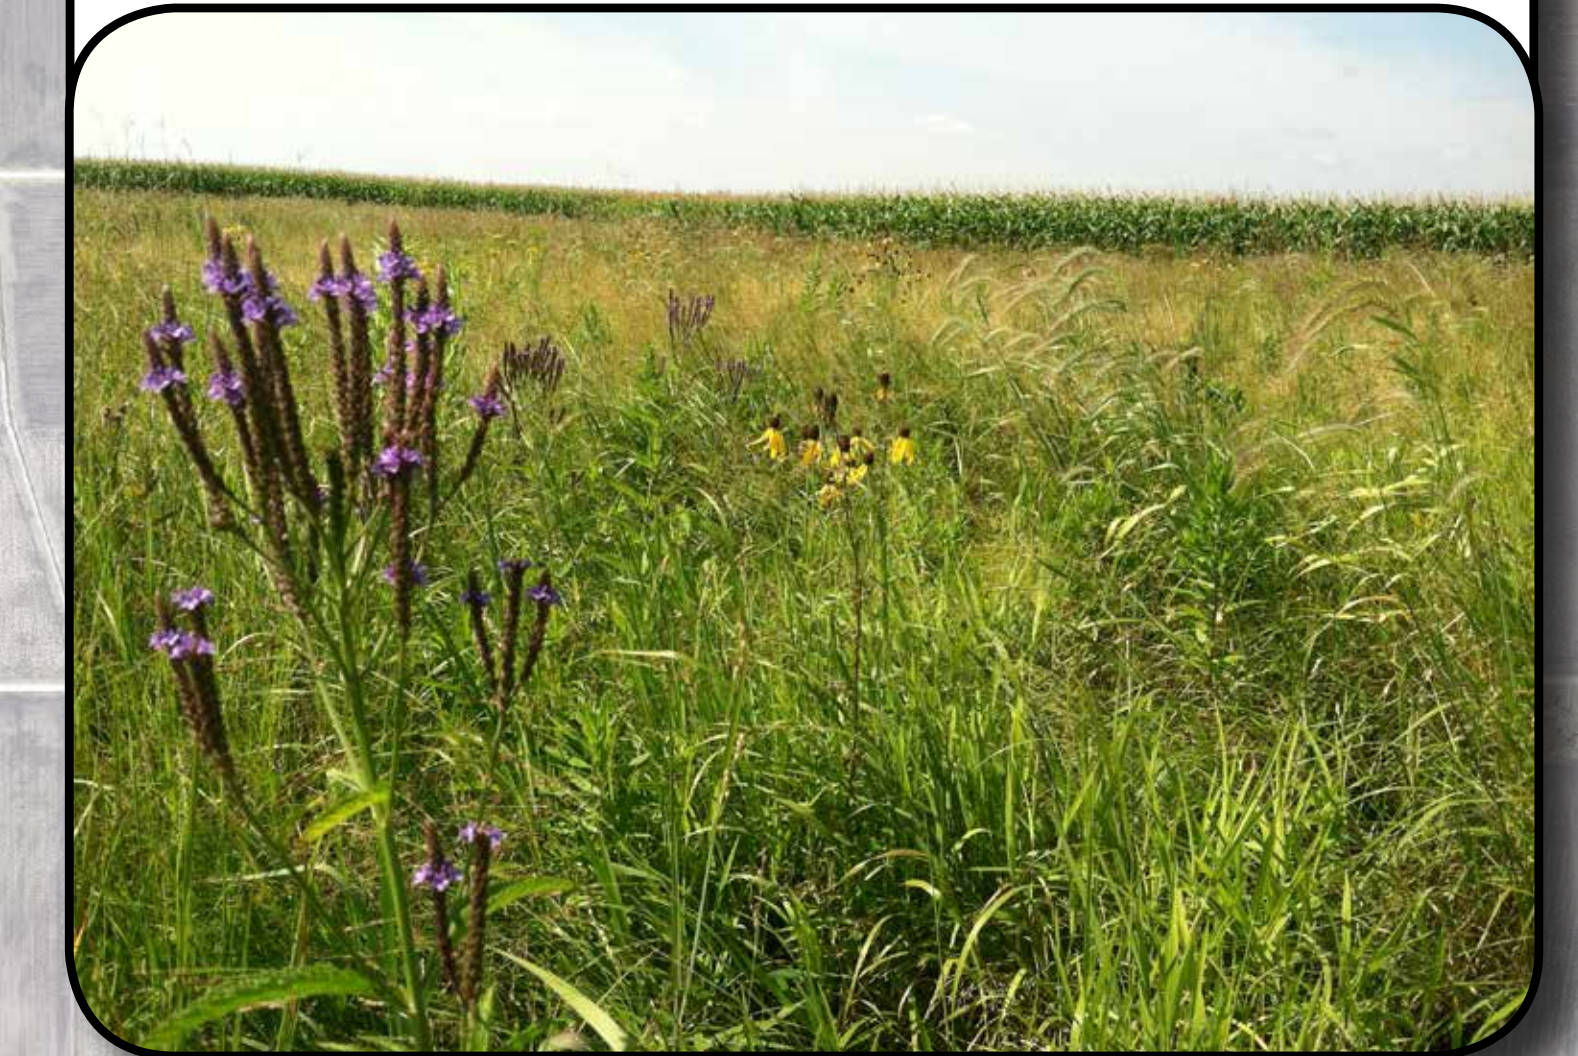
### Water Quality: Native Plantings/Buffer Strip

Native vegetation has a number of benefits over domesticated cover crops, including deep roots systems and high tolerance to environmental conditions. Native vegetation was specified in areas that were suitable to assist with infiltration, nutrient uptake, and ongoing maintenance costs.

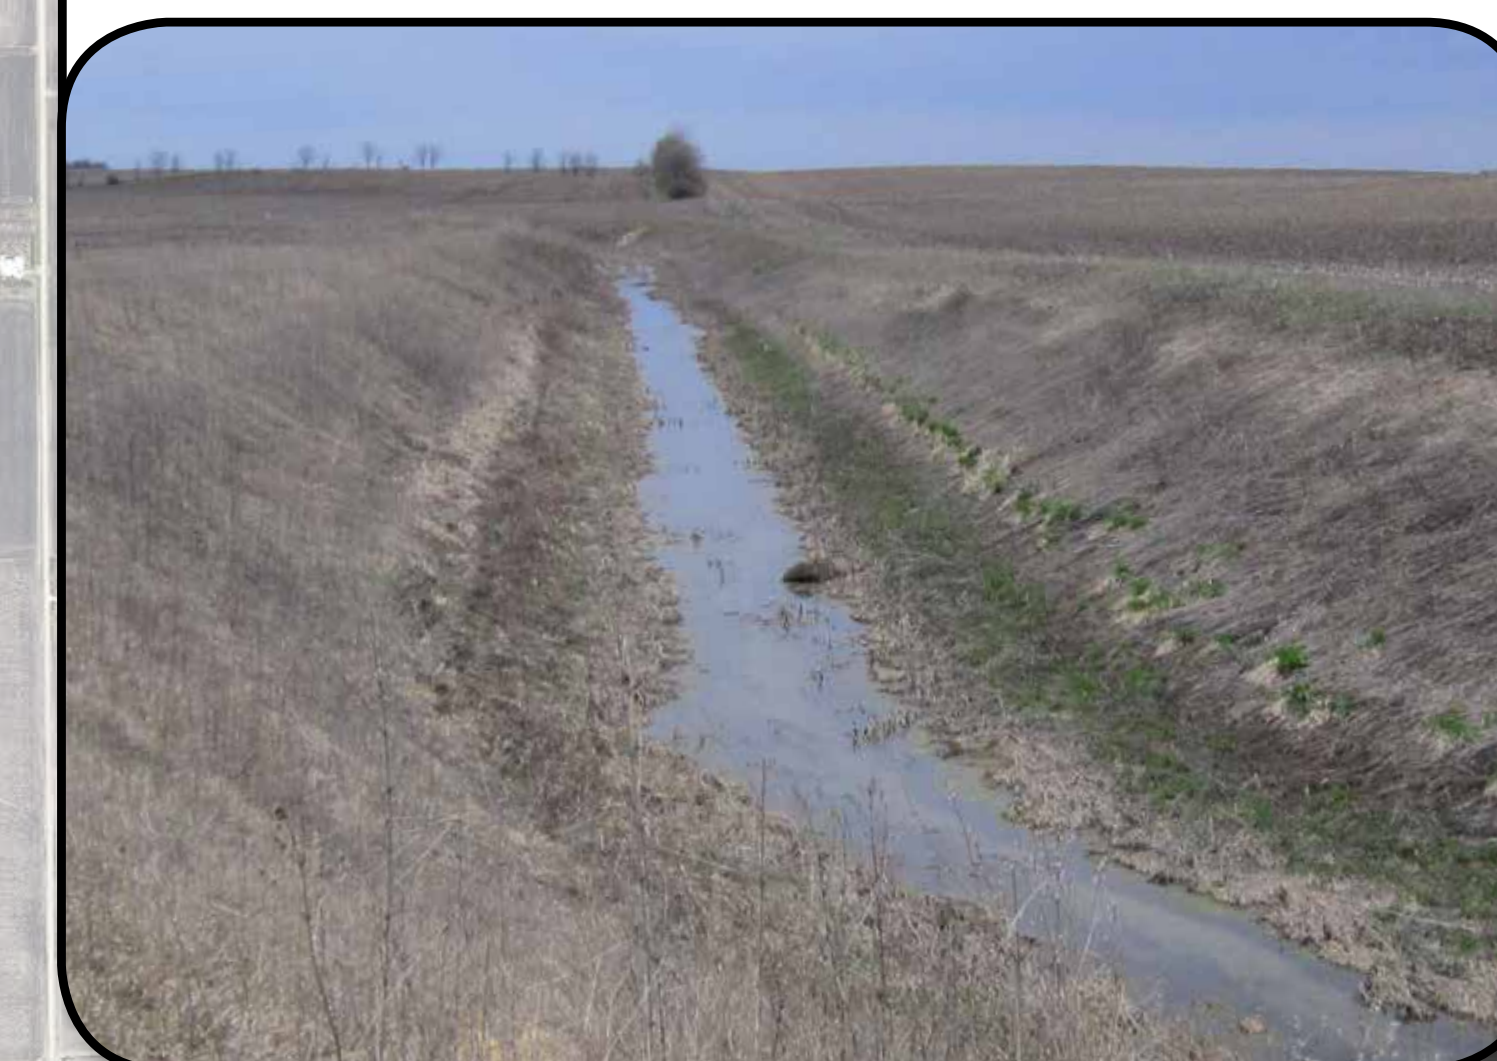
### Water Quality: Two-Stage Ditch Design

Two stage ditches are designed to effectively treat low flow conditions while still providing conveyance for high flows. In this system, the two stage ditch segment was constructed immediately downstream of the Klein Pond.
