# Reduce vehicle-animal collisions with installation of small animal exclusion fencing

**JUNE 2022**

Research Report  
Final Report 2022-19

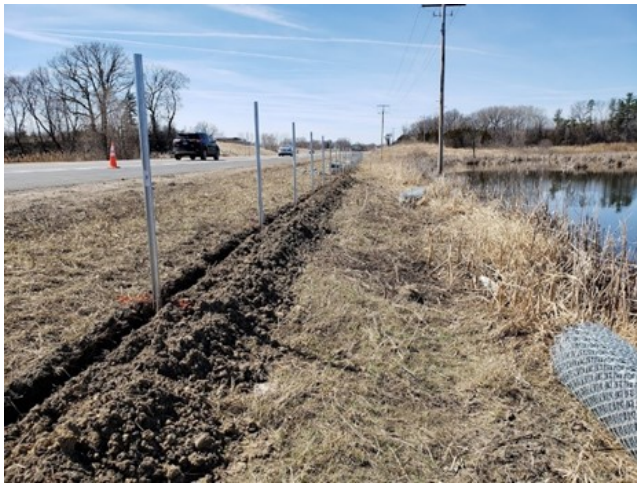
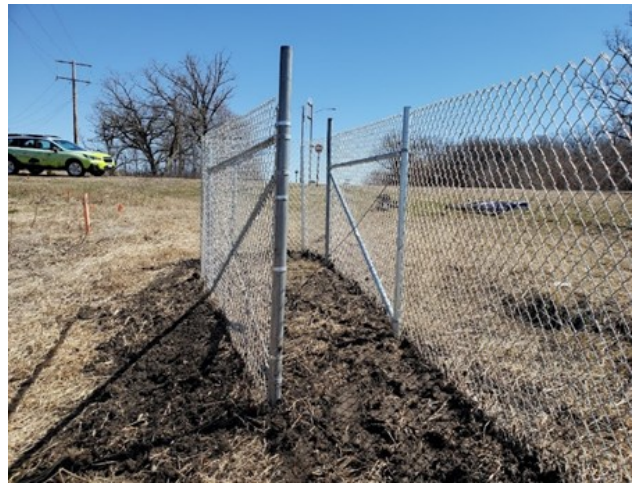
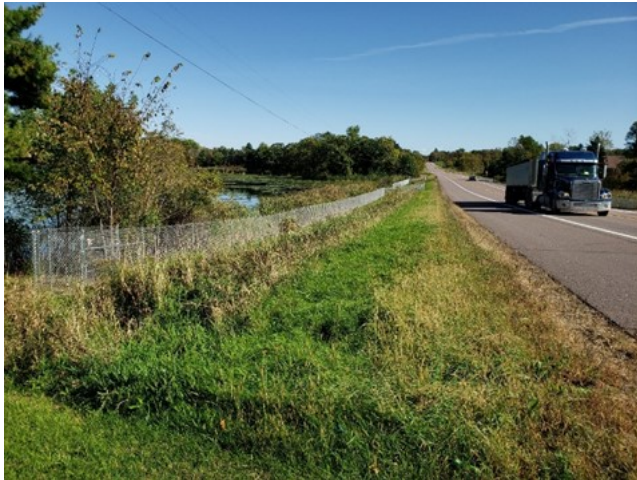
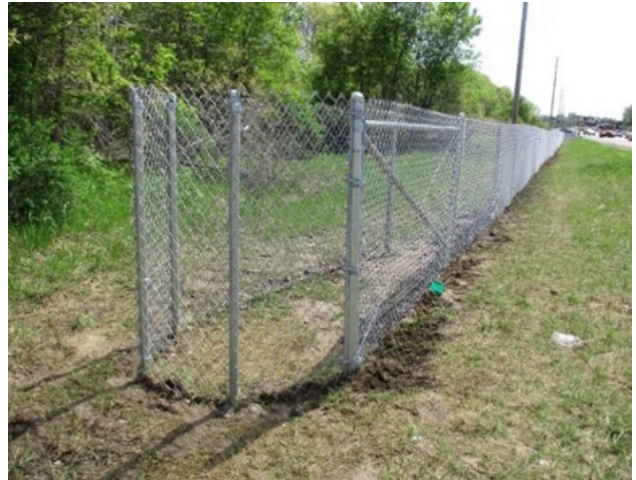
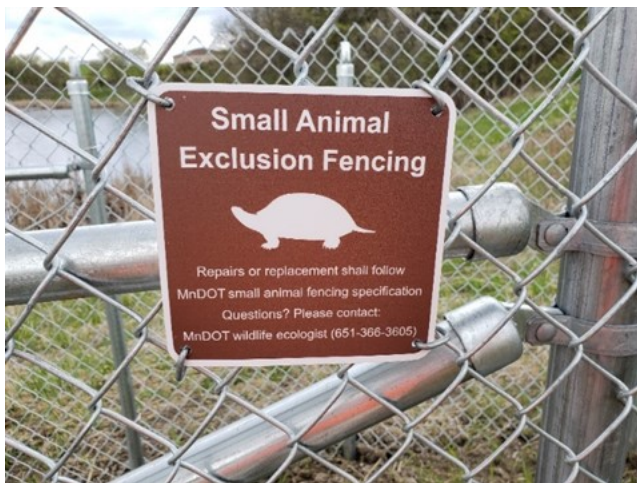
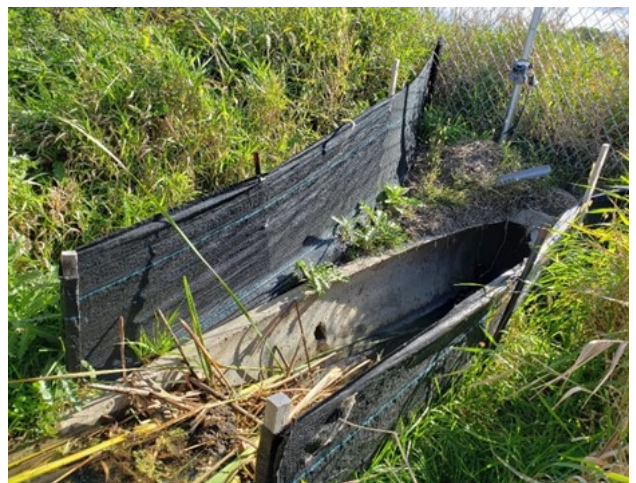
**Figure 2. Initial chain-link fence treatment sites. Top: Site preparation and installation of posts and wrap-around end treatments. Middle: Completed chain link fence and end treatment. Bottom: left- MnDOT signage, right- silt-fencing to guide animals into culvert opening.**

Fencing lengths were sized to cover the areas with the greatest number of turtle crossings, acting as a barrier for the whole length of the wetland on each side of the road, plus a buffer area. Total fencing lengths were: 1640 ft (S.4), 1340 ft (N.5), 610 ft (W.17), and 1640 ft (W.18). Culverts were located at 2 of 4 treatment sites (N.5 and W.18) and were situated well within the bounds of the fence. Where fences were further from culvert openings, short segments of silt fencing were installed to help direct turtles from the fence into the culverts (Figure 2).

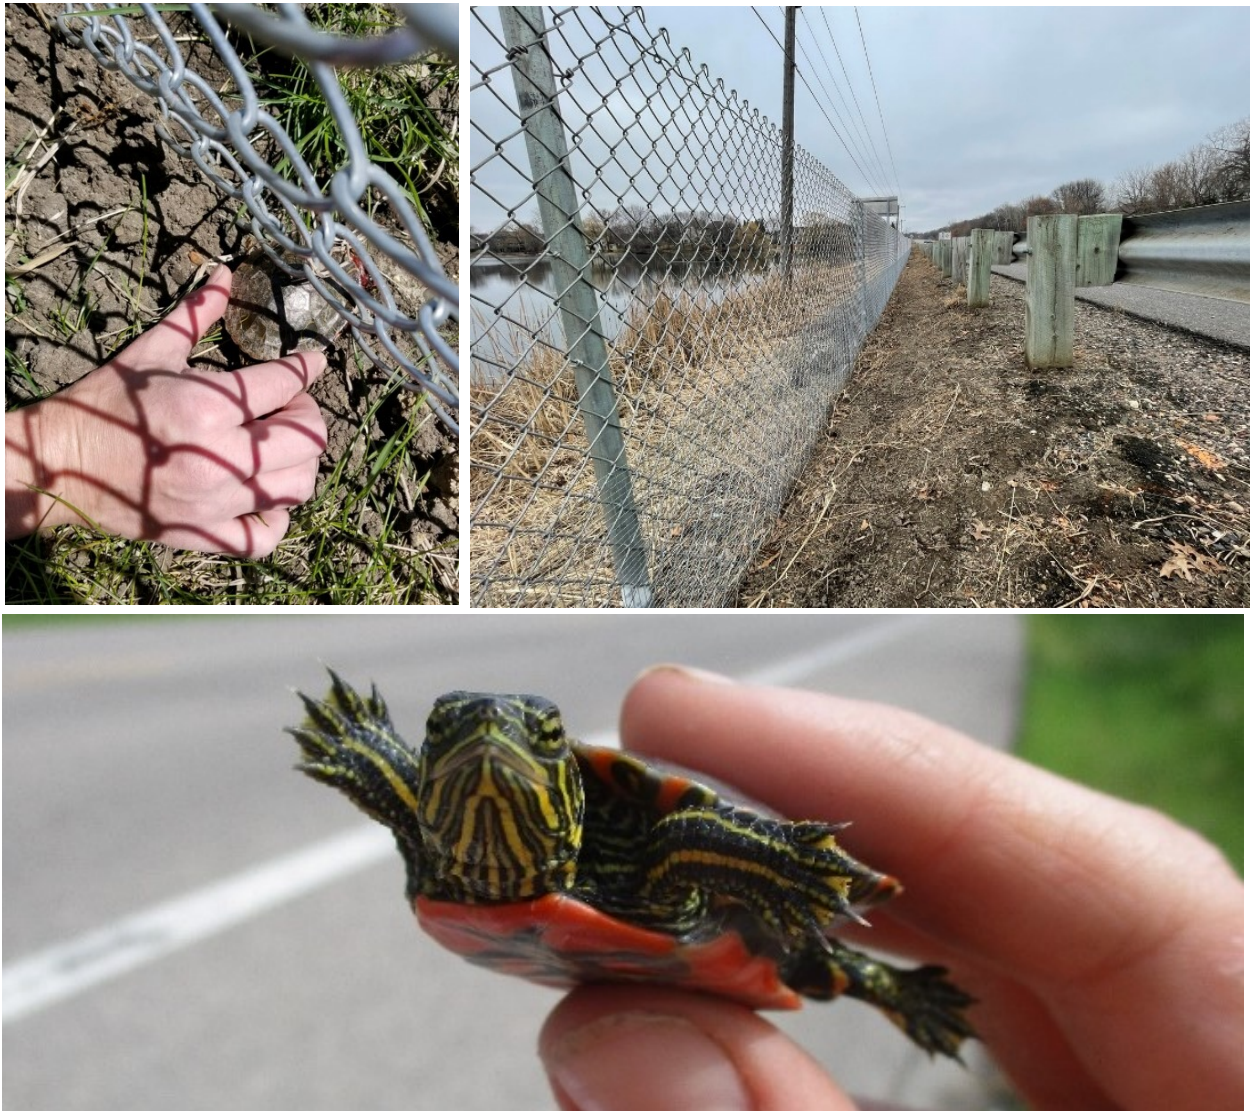
**Figure 4. Top left: Small (i.e., juvenile turtles less than 2 inches in width) are able to fit through standard chain-link fence mesh and access roadway. Top right: Hardware cloth was retrofitted onto the existing chain-link fence at 3 of 4 treatment sites in 2021. Bottom: Small painted turtle found on roadway.**

the standard 2" chain link fence mesh (Figure 4). To further mitigate mortality of smaller turtles, 3 of the 4 existing fences (W.18, N.5, and S.4) were retrofitted with fine, 19 gauge (½ inch) hardware cloth. Selection of these three sites was based on the presence of small turtles and the logistical feasibility of hardware cloth installation. Because we did not document the same level of mortality of small turtles at the fourth site (W.17), hardware cloth was not installed there. This installation was completed in late March, 2021. The hardware cloth was attached directly to the existing fence, buried 6 inches below ground, and extended 2 feet above ground (Figure 4). We hypothesized that most small turtles would be unable to climb above this height.

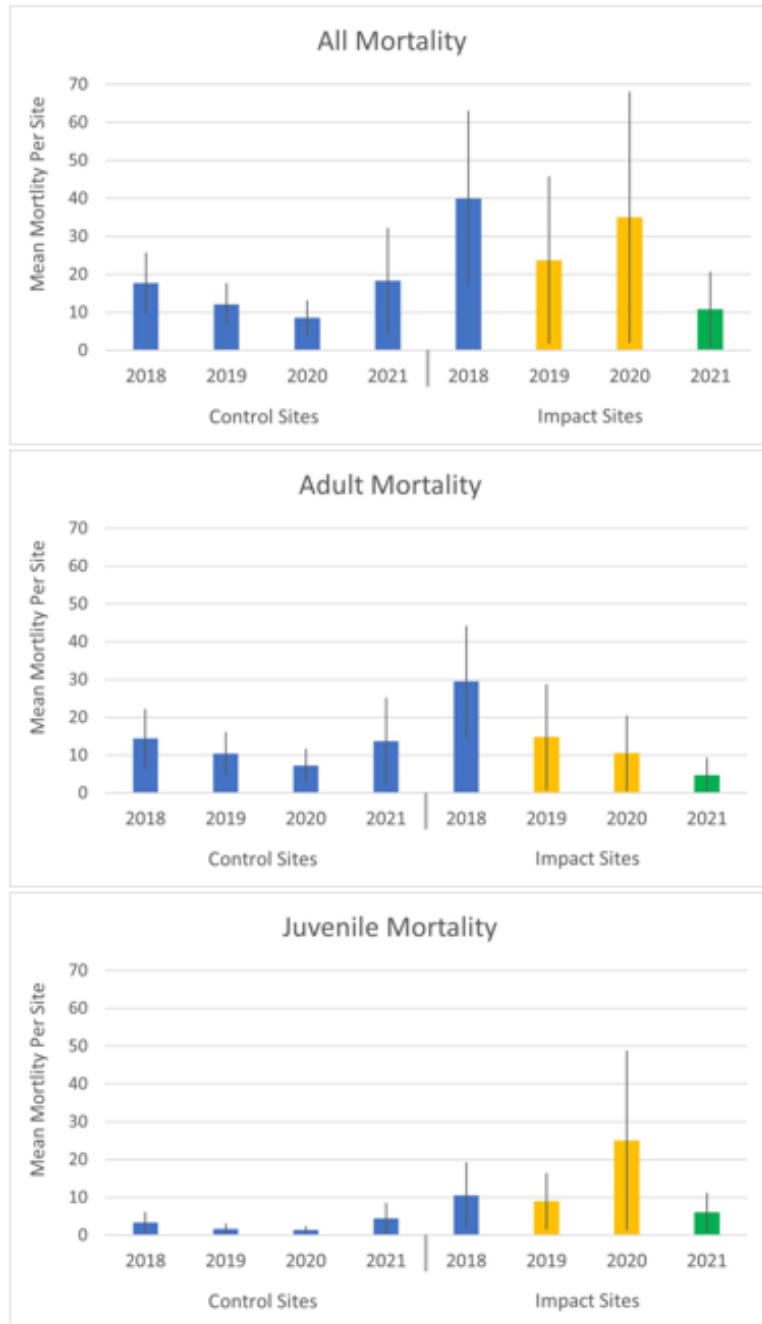
Figure 6. Mean turtle mortality per site by year and treatment (Control versus Impact) for each size class: All Turtles (top), Adults (middle), and Juveniles (bottom). Blue indicates no treatment, orange is chain-link fencing, and green is fine mesh retrofit. Error bars represent standard error about the mean. Note that mortality data for site N.5 is included in 'Impact' for 2019 although fencing was not installed there until late in the season.

and Treatment (Table 8; Figure 6), providing strong support that the retrofitted fence reduced mortality over standard chain link fence. This interaction was statistically significant for both adults and juvenile turtles when tested separately.

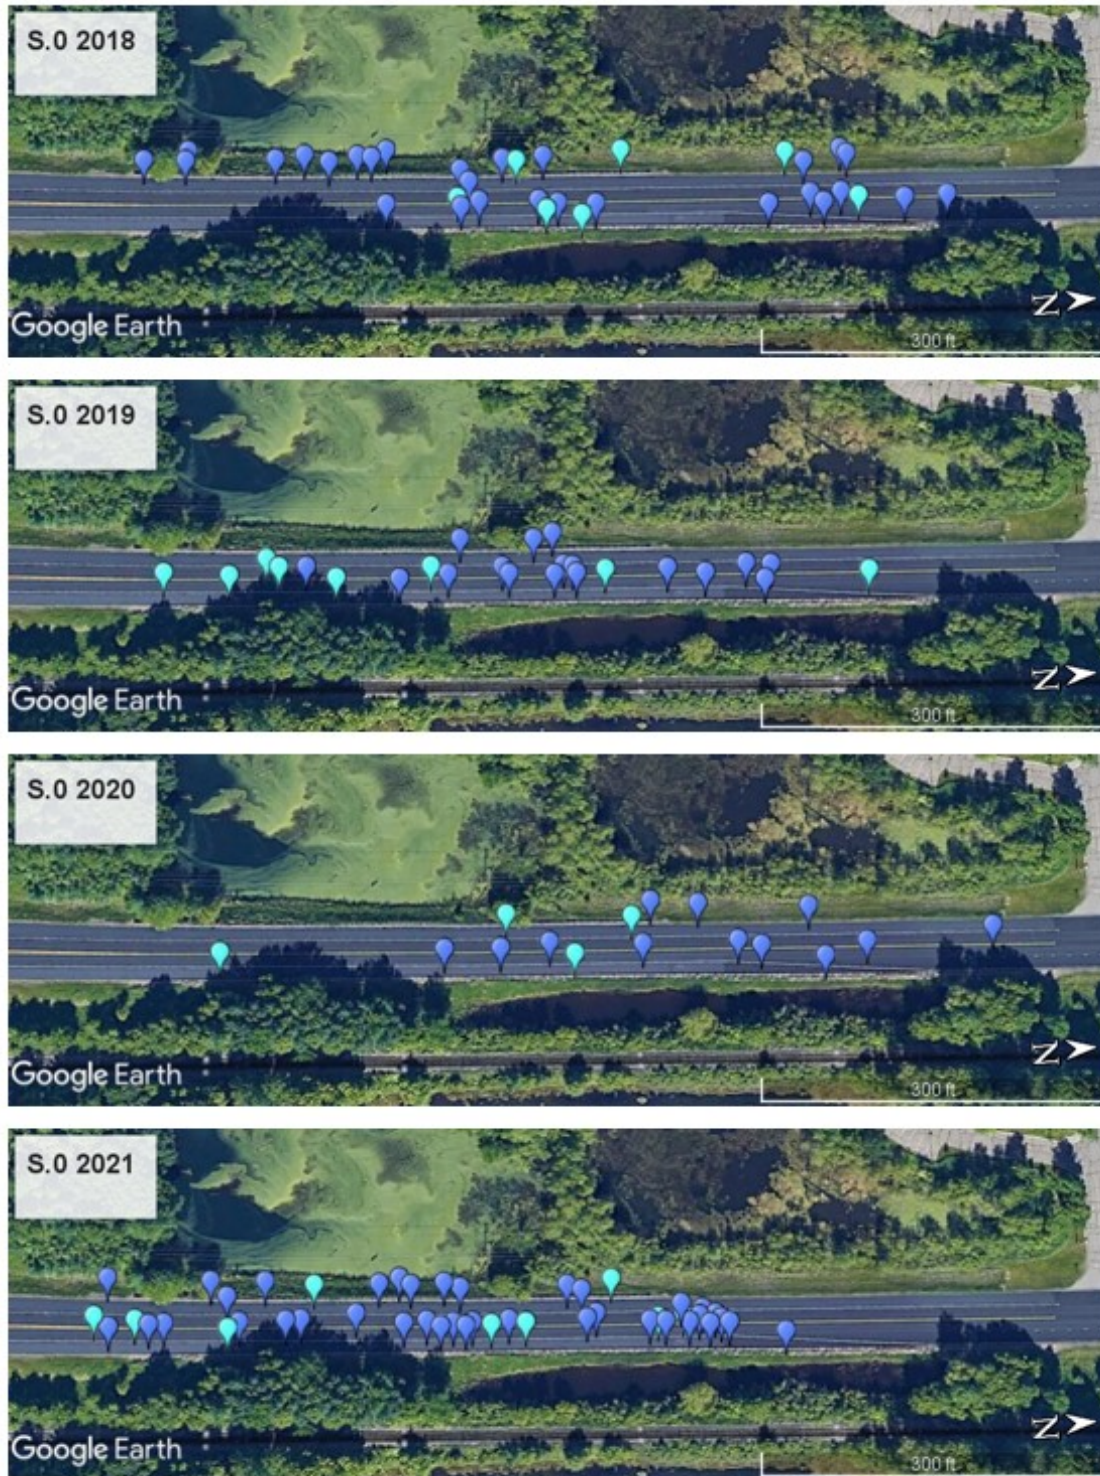
Figure 7. Turtle mortality data by age class (Dark blue = Adults, Light blue = Juveniles) at Control site S.0 in Egan during 2018 (n= 35), 2019 (n=26), 2020 (n=15), and 2021 (n= 47).

Observations at control sites remained relatively consistent among years, but we did observe modest declines at some sites in 2020 followed by an increase in mortality in 2021 (Figure 7). We note that our inclusion of random effects can help to control for such variation.
